Replacing damaged bulkheads

By Dan Witucki

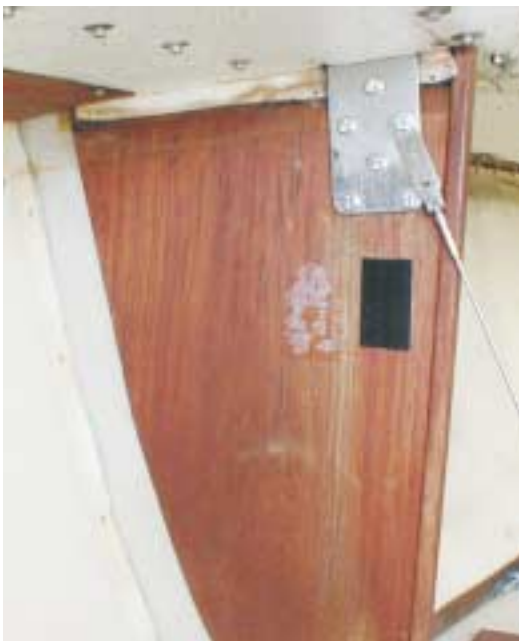
After limping back to the dock and examining the damage, we decided to completely replace the bulkhead on both sides of the boat. Over the years, the chainplates had been leaking and had delaminated and rotted the plywood bulkheads. Before the accident, the bulkheads looked fine, but it was amazing to see afterward how badly they actually had deteriorated. With the end grain of the plywood bulkhead up against the underside of the deck, the chainplate was leaking directly onto the exposed end grain of the wood. Water damage was inevitable (*photo below*).

Right—The port bulkhead with the chainplate still attached.

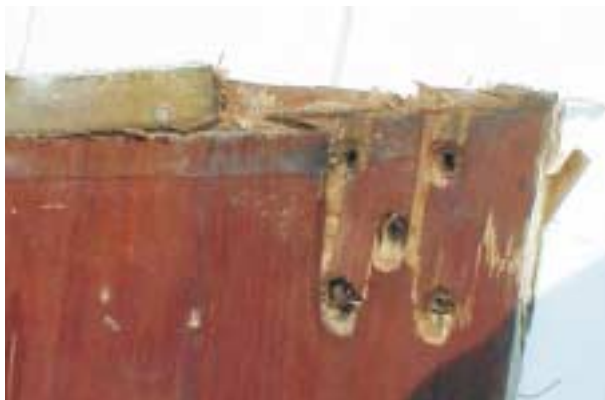
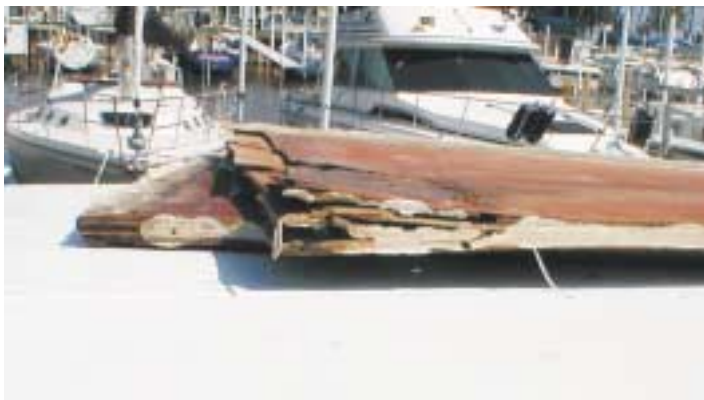
If you race a sailboat long and hard enough, it eventually will reveal its weaknesses, sometimes violently. My friends and I race an Evelyn 32-2 called *Rush*. Less than a month before the 2002 Mackinaw races, we were competing in the Saginaw Bay Yacht Racing Association, Gravelly Shoals race. Throughout the race the wind had been building and we were a little overpowered with a full main and 150% head sail. We had completed about 45 miles of the 50-mile race when the starboard chainplate decided it had enough and pulled out of the bulkhead.

Below—Two views of the starboard bulkhead where the chainplate let go shows the result of accumulated water damage and heavy loads.

The next decision that had to be made was what material to use for the bulkheads. The original bulkheads were made of " marine grade mahogany plywood. However, we weren't too anxious to use plywood again. It would be quick and easy; but we wanted something more bulletproof than plywood. After talking to Gougeon technical advisor, J.R. Watson, we decided to go with an epoxy/fiberglass composite called G-10. We selected 1/2" G-10 to replace the " plywood. Because of G-10's strength, we could have gone thinner yet. However, that would have made it more difficult to install and have everything else match up.

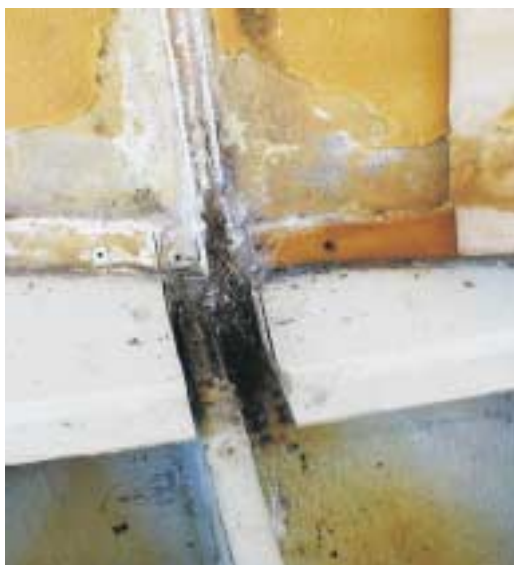
The bottom of the bulkhead/hull joint before the old tabbing was removed. We would extend the bottoms of the new bulkheads so they could be bonded to the side of the floor that ran transversely across the bottom of the hull.

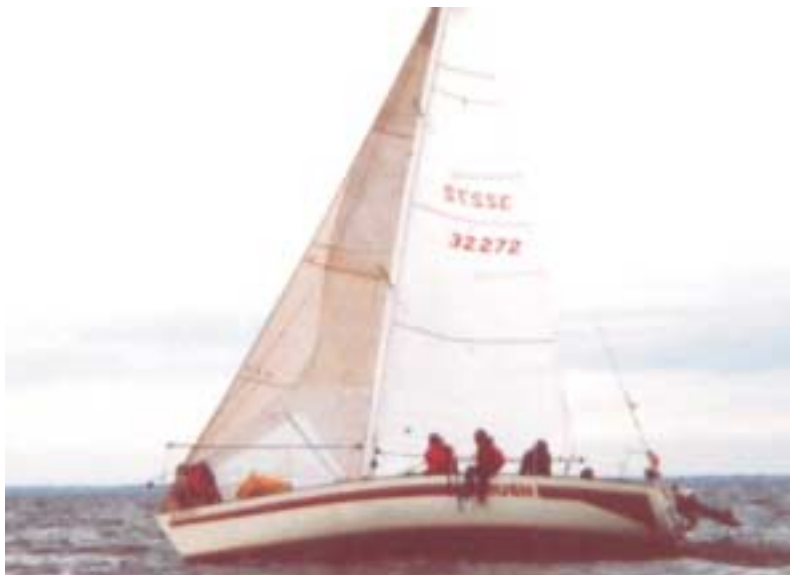
Rush is back in action. Several weeks later, the new bulkheads proved they could handle the stress of a heavy knockdown and a major storm during the infamous 2002 Chicago to Mackinac race.
