# Revisiting a church window restoration

By J.R. Watson

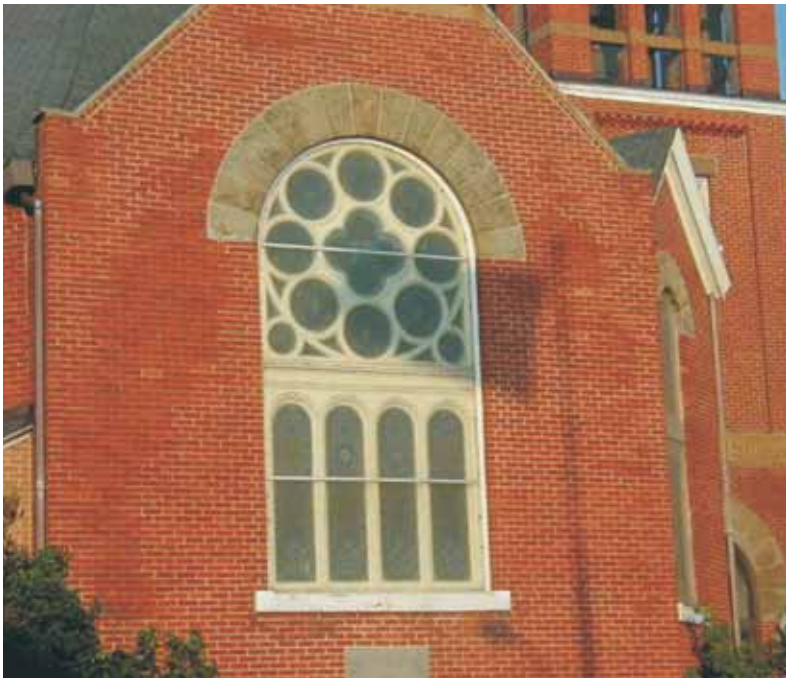
**The United Methodist Church in Ludington, Michigan, as it looked several years after the stained glass window frames were restored with WEST SYSTEM® epoxy.**
