EPOXYWORKS®

Number 19 ■ Spring 2002

Testing large bonded-in fasteners

By Brian Knight

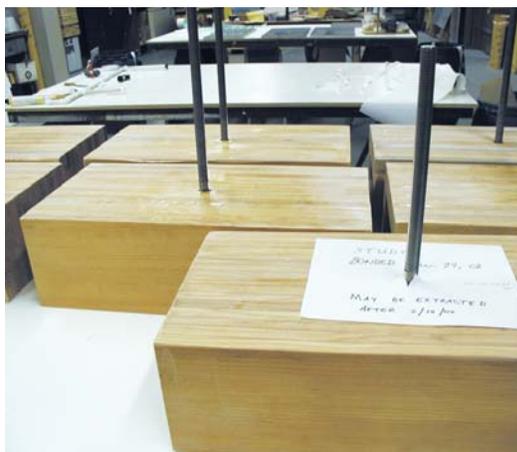
The 3/4" diameter stainless steel bolt test samples before the test. In these samples, the rods were imbedded parallel to the glue joints.

(Although the boat's hardware will be fastened with bolts, for the tests we used threaded rods of the same diameter and material.)

For the tests on the 3/4" stainless steel rods, we built seven laminated wood blocks, 12" x 24" x 5 1/2" thick. All were laminated 3/4" clear Douglas fir. The photo (top) shows how the bolt was oriented relative to the grain of the wood. We drilled one " diameter hole into each of these samples and bonded a rod in the center of each

hole. Two of the rods were imbedded 5" deep and five rods were imbedded 6" deep.

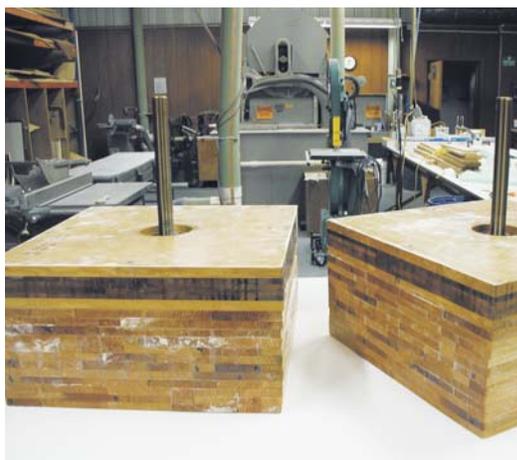
The 1 1/2" diameter silicon bronze bolt test samples before the test. In these samples, the rods were imbedded perpendicular to the glue joints. The top six laminations represent Scheherazade's outer skin over a heavy laminated frame.

Additionally, Lloyd's requested two more tests on the much larger 1½" silicon bronze fasteners that would be used to hold the propeller strut to the bottom of the hull. The force required to extract these fasteners was expected to be very large (50,000 lb+), so we increased the size of the panel to 24"×24"×12" thick. The wood grain is oriented differently in this test than in the ¾" rod test (*middle photo, previous page*). This reflects the way the grain is oriented in the hull of the boat. Each fastener was bonded into a 1" hole drilled 9" deep.

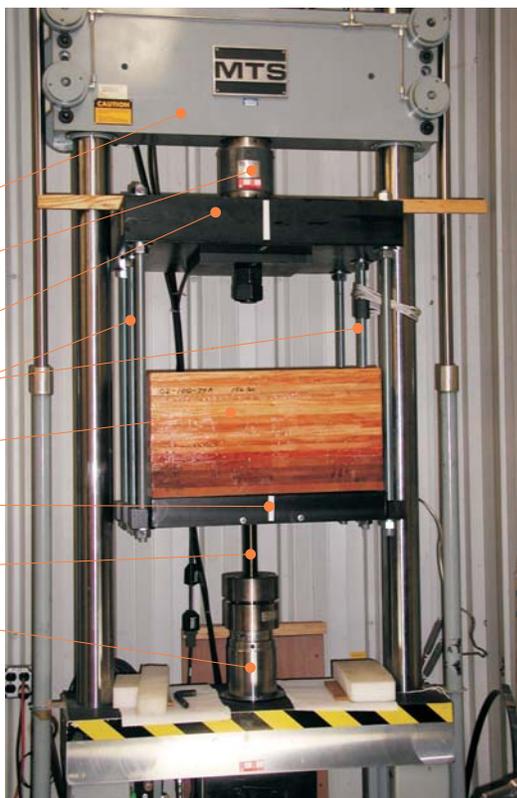
The MTS test machine with the test apparatus and 1 1/2" silicon bronze bolt test sample before the test.

- Test frame crosshead
- Load cell
- Monolith
- 1" steel rods
- Test block
- Frame
- 1 1/2" bronze rod
- Test machine actuator

The end of the bonded-in fastener is threaded into a socket on the actuating cylinder on the base of the test machine. The test is performed by pulling the bonded threaded rod downward out of the wood block. We knew that we needed a very substantial method of holding the wood sample up while the fastener is withdrawn from it.

The wood block is held in a "steel angle frame. The frame is suspended by six 1" threaded steel rods attached to a wood/steel composite slab just below the top of the steel frame. The slab is a 4½" thick plywood core sandwiched between two pieces of ¼" steel, bonded together with epoxy, and nicknamed "the Monolith" (from the movie *2001: A Space Odyssey*). The Monolith is anchored to the crosshead of the MTS Test Frame with a 2" diameter bolt. At the very top of the test apparatus is the cylindrical load cell, which measures the force the machine is exerting on the fastener.

It is not an easy thing to hold onto a piece of wood and pull on the other side of it to the tune of more than 50,000 lb, but that is exactly what we hoped our apparatus would do. Between the frame, the six steel threaded rods, the Monolith, the 2" diameter bolt, the 1½" silicon bronze threaded rod, and a test machine with a pulling capacity of 100,000 lb, something has to go. We hoped it would be the epoxy joint or the wood, not the fixture or the test machine.

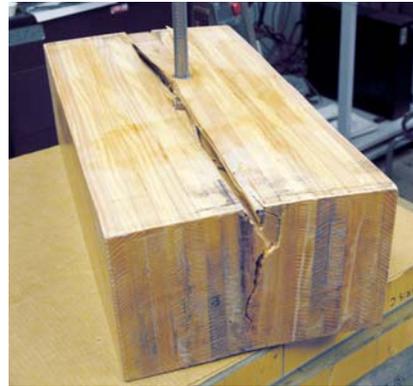
In the smaller, ¾" rod tests (*left and middle*), with the rod imbedded parallel to the glue joints, the damage looked quite different than it did in the larger 1½" rod test (*bottom*), with the rod imbedded perpendicular to the glue joints. The quality of the wood in the samples also varied between the two tests.

In both tests, the machine's travel limit was set to 1", so the rod remained partially imbedded in the block.

It took an average of 22,000 lb of force to remove the ¾"×6" embed, 19,400 lb to remove the ¾"×5" embed and 55,000 lb of force to remove the 1½"×9" embed silicon bronze rods. The force required in pounds per square inch

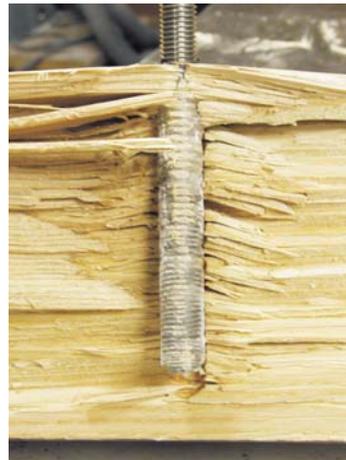
A tested 12"×24"×5½" sample was split apart after a test. This sample had a large crack running the complete length of the sample after the test had finished (*above*). I drove a wedge into the crack which split the block the remaining distance. The photo (*left*) shows how the wood adjacent to the threaded rod was destroyed—graphic evidence of the forces exerted during this test.

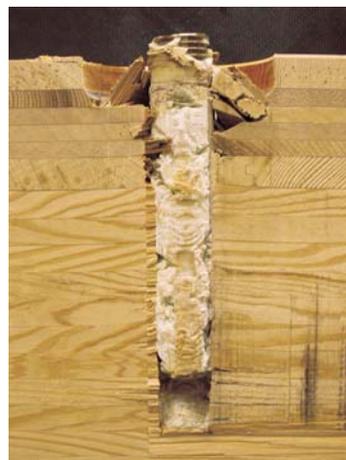
A tested 24"×24"×12" sample was cut apart on a large band saw so we could examine what happened in the area around the bolt. The photo (*left*) shows that the wood was permanently deflected around the bolt. You can see the distortion in the glue line where the wood was bent in the direction of the bolt movement. The wood fiber closest to the bolt is distorted more than the fiber farther from the bolt. This is the result of the wood compressing near the bolt and crushing. Farther away from the bolt, the distortion becomes less noticeable until, a few inches from the bolt, there is no visible deflection. ■
