Custom fiberglass boat repair

By Rich Simms, NMSC

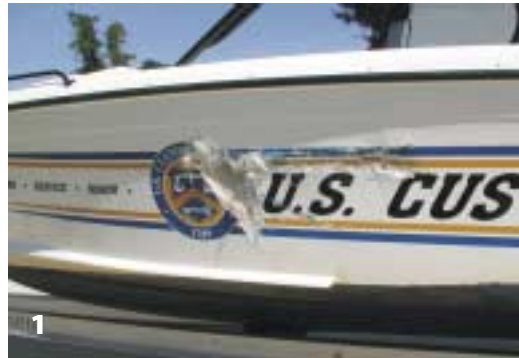
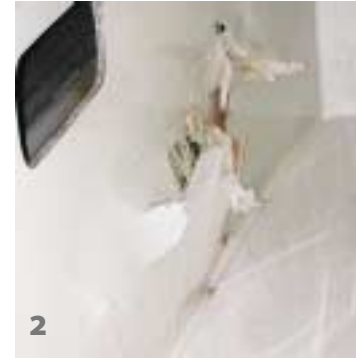
Vessels used by the Bureau of Immigration & Customs Enforcement (ICE) can be subjected to severe conditions during law enforcement operations. Occasionally, the intense interaction between law enforcement vessel and suspect violators can result in unwanted vessel damage. The damage on this ICE interceptor was the result of intentional impact by a suspect vessel (*Photos 1 and 2*).

This vessel was sent to the ICE National Marine Support Center (NMSC) in St. Augustine, Florida. The NMSC site is operated by Global Marine Systems Inc, the national marine maintenance contractor for ICE. The port hull and inner liner were significantly damaged as a result of the impact. The damage was assessed and determined to be repairable as no major structural components were compromised.

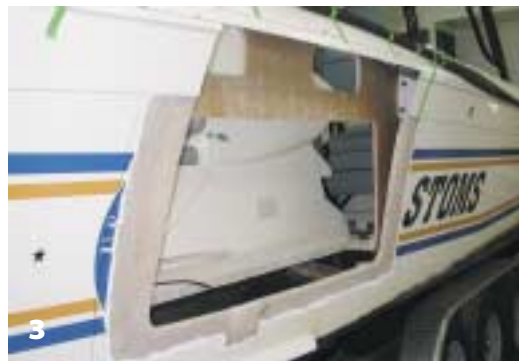
All damaged sections were removed. The outer hull was cut and trimmed to allow access to the inner liner and a small section of the deck, which also had to be replaced (*Photo 3*). Interior components were inspected to locate hidden damage (*Photo 4*).

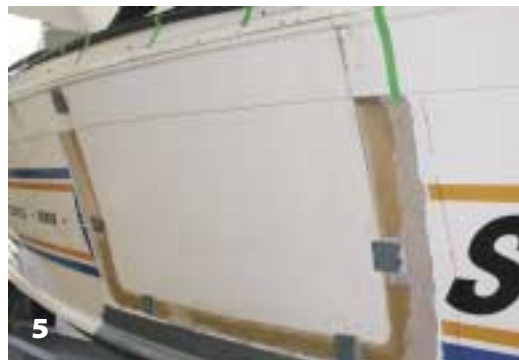
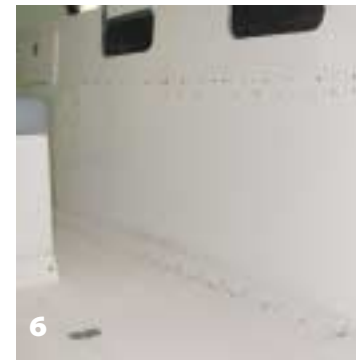
Precise measurements were taken of the damaged area. Global Marine Systems then contacted the vessel manufacturer (Midnight Express) to fabricate panels with the identical schedule and compound curves. The replacement panels were ordered slightly larger than the actual damaged area. This facilitated exact trim-to-fit panels. WEST SYSTEM® epoxy was used to bond the new panels in place (*Photos 5 and 6*).

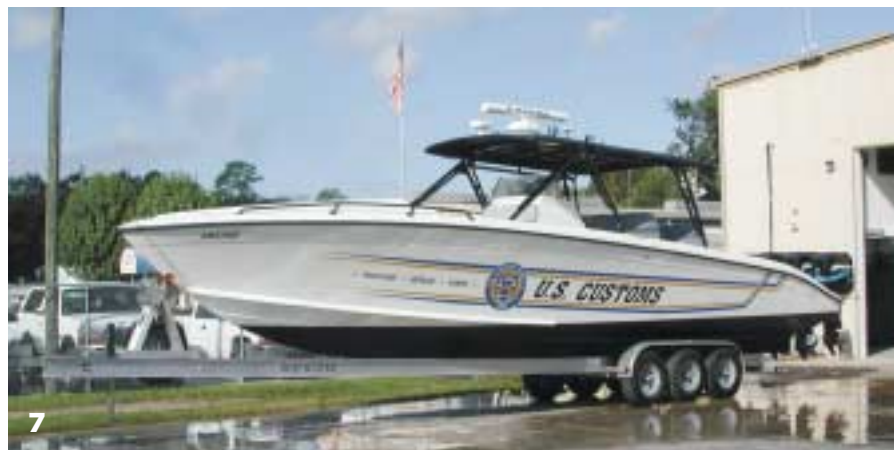
The final repair stage included graphic application (*Photo 7*).
