# Revisiting a church window restoration

By J.R. Watson

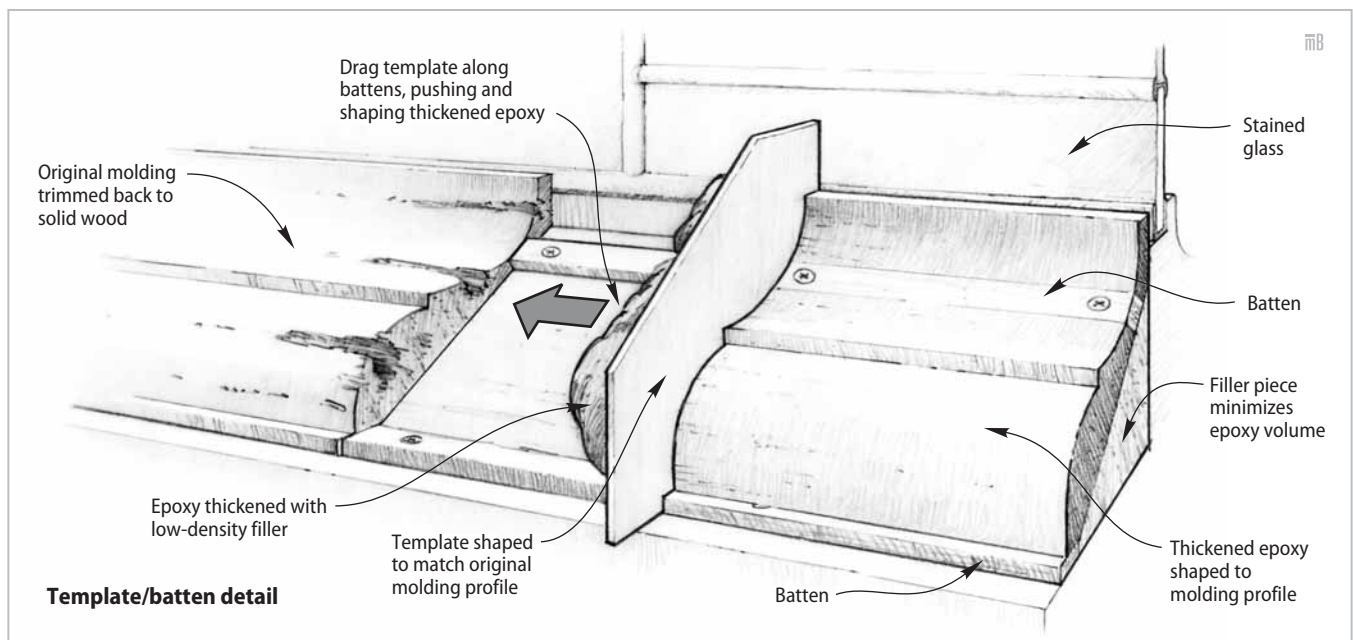
Where components previously had been joined in the windows, laps and an adhesive were used. With time, this adhesive failed and the joints

were loose. We lightly pried the joints apart and slid an epoxy-wetted business card (someone else's as we didn't have business cards then) into the joint and clamped it together. Where rails butted the stile and were loose, we toenailed with wooden dowels (or threaded rod in high-load areas). If the butt joint could be opened with a saw blade, we worked epoxy in to aid joining, but the dowels yield lots of bonding area to the butt joint and tie the two structural components together. We drilled holes diagonally through the rail and into the stile and then dribbled clear epoxy down the holes. Dowels were cut a little long, then thoroughly wetted and driven in place. Usually, we drilled slightly oversized holes ( $\frac{1}{16}$ " hole for a  $\frac{1}{2}$ " dowel) so the dowel could be slid into place. After curing, the dowels were cut flush.
