# Building *Alligator*

By Bob Walters

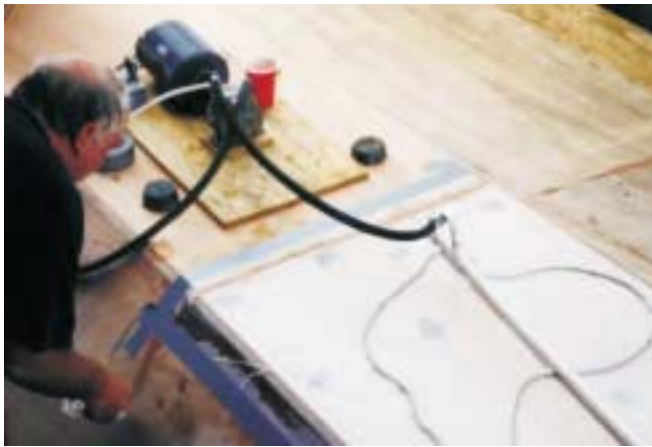
**Left**—Bob used a cheap surplus vacuum pump, ordinary building supply plastic film for the bag, bubble wrap, a length of old rope to distribute the vacuum, and duct tape to seal the edges of the bag.

My vacuum equipment was not very sophisticated. I used a cheap surplus vacuum pump, ordinary building supply plastic film for the bag, bubble wrap, a length of old rope to distribute the vacuum, and duct tape to seal the edges of the bag.

Even with this rudimentary equipment, I was able to produce amazing clamping forces. Even the largest panels with the most severe curvature pulled into position easily. This system worked well and the good clamping pressure was later confirmed when I cut out holes for the through hull fittings. The thin glue line between the two layers looked just like it was made at the plywood factory.

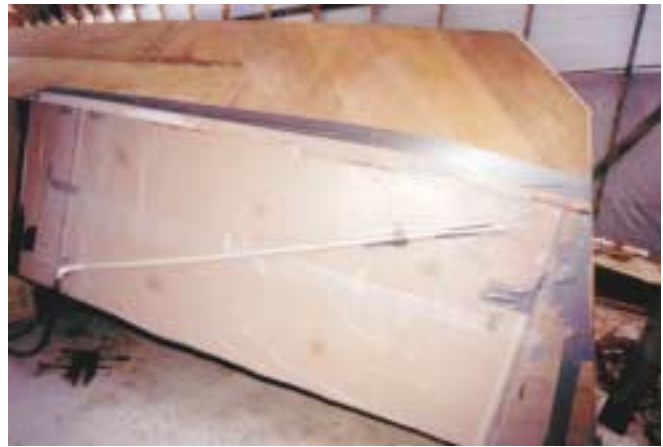
**Right**—This system worked well and provided good clamping pressure for even the largest panels.

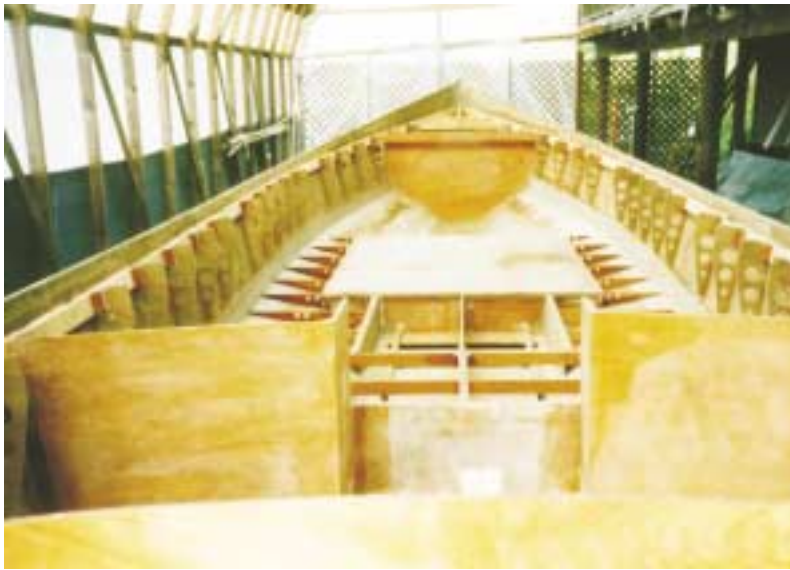
After applying bottom paint and priming the topsides, Bob turned the hull right side up using external rolling frames, a pair of chain hoists and the help of a friend.

After preliminary fairing, the hull received a single layer of 8 oz fiberglass cloth. Next we faired and long-boarded the hull. I applied bottom paint and primed the topsides. Then I made another pair of external frames and turned the hull right side up, again using a pair of chain hoists and the help of a friend.

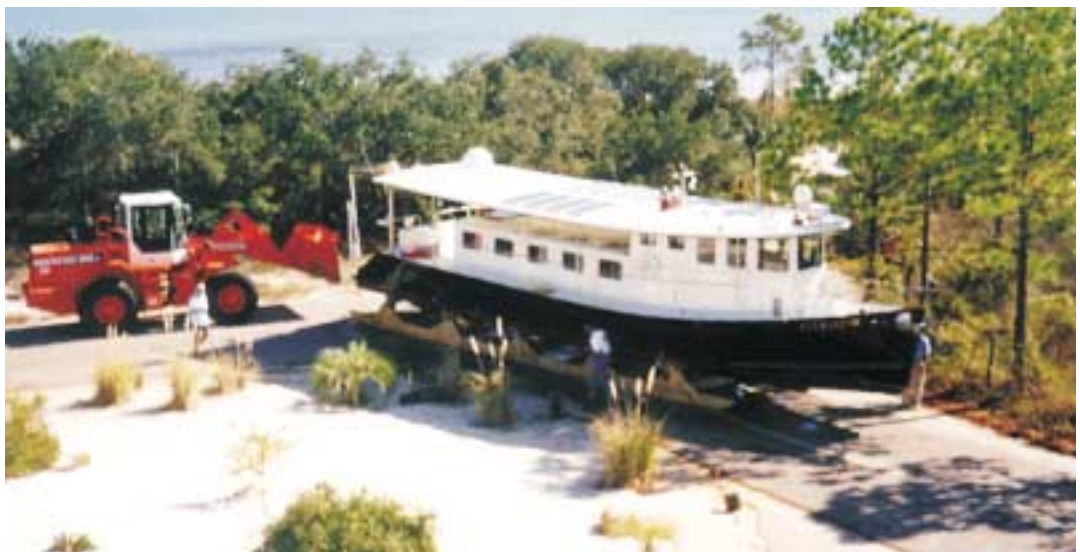
After 5½ years of construction, *Alligator* is moved, with the help of some heavy equipment, from the building shed to her launching site.
